Manhole Inspection Summary

Manhole # S37W1_006MH

Insp Date: **11/21/07 7:59 AM**

Location Address: **3555 HANOVER ST**

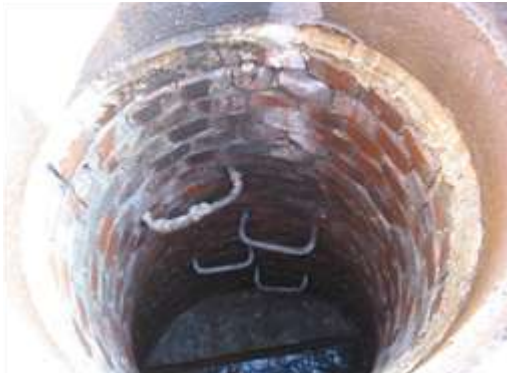
Steps

Count: **4** Missing: **0** ☐ Corroded

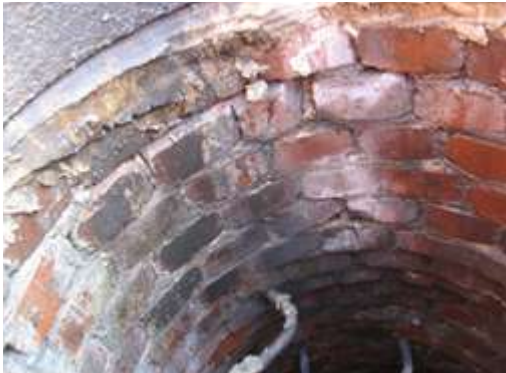
Defect 1

Condition: ☒ Sound ☐ Cracked ☐ Root Intrusion ☐ Loose Brick ☐ Deteriorated

Infiltration: ☐ None ☒ **Joint** ☐ Cracks ☐ Mortar ☐ Roots ☐ Wall

Chimney

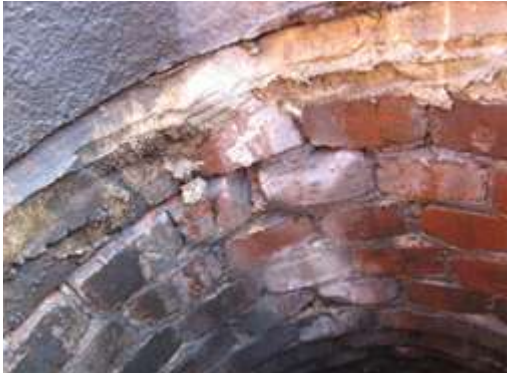
Defect 2

Condition: ☒ Sound ☐ Cracked ☐ Root Intrusion ☐ Loose Brick ☐ Deteriorated

Infiltration: ☐ None ☒ **Joint** ☐ Cracks ☐ Mortar ☐ Roots ☐ Wall

Corbel

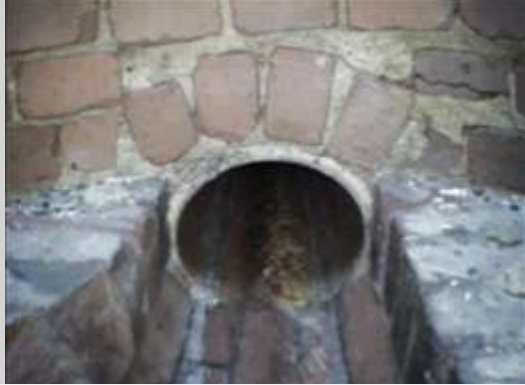
12 O'Clock Outflow

8 in. Circular Gravity Sewer
Pipe Out @ 12 O'Clock

Pipe Height: **10.8** (in.) Rod and Bar (Angled)
Pipe Material: **Clay** ☐ Pipe Lined
Invert Depth: **9.86** (ft.) Flow Characteristics: **Fast**
Deposits: ☐ None ☒ **Mud** ☒ **Sludge** ☐ **Debris** ☐ Grease
Silt Depth: **1** (in.) Deposits Extent: **Medium**
Infiltration: **None** Pipe Seal Cond: **Sound**

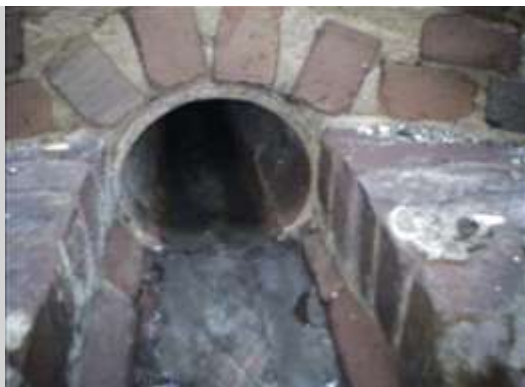
6 O'Clock Inflow

8 in. Circular Gravity Sewer
Pipe In @ 6 O'Clock

Pipe Height: **9.6** (in.) Rod and Bar (Angled)
Pipe Material: **Clay** ☐ Pipe Lined
Invert Depth: **9.64** (ft.) Flow Characteristics: **Fast**
Deposits: ☐ None ☒ **Mud** ☒ **Sludge** ☐ **Debris** ☐ Grease
Silt Depth: **1** (in.) Deposits Extent: **Light**
Infiltration: **None** Pipe Seal Cond: **Sound**

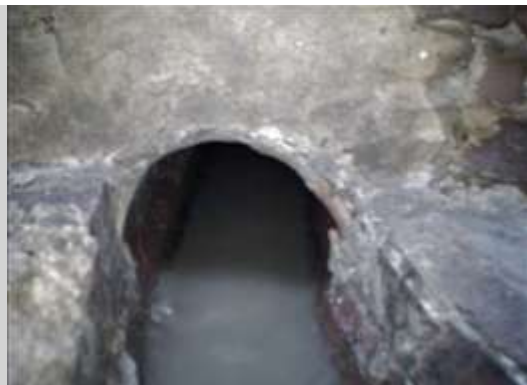
9 O'Clock Inflow

8 in. Circular Gravity Sewer
Pipe In @ 9 O'Clock

Deposits: ☐ None ☒ **Mud** ☒ **Sludge** ☒ **Debris** ☐ Grease

Silt Depth: **1** (in.) Deposits Extent: **Medium**
